# Edina Morningside Church

## Capital Campaign

## Trustees Project Presentation

24 January, 2016

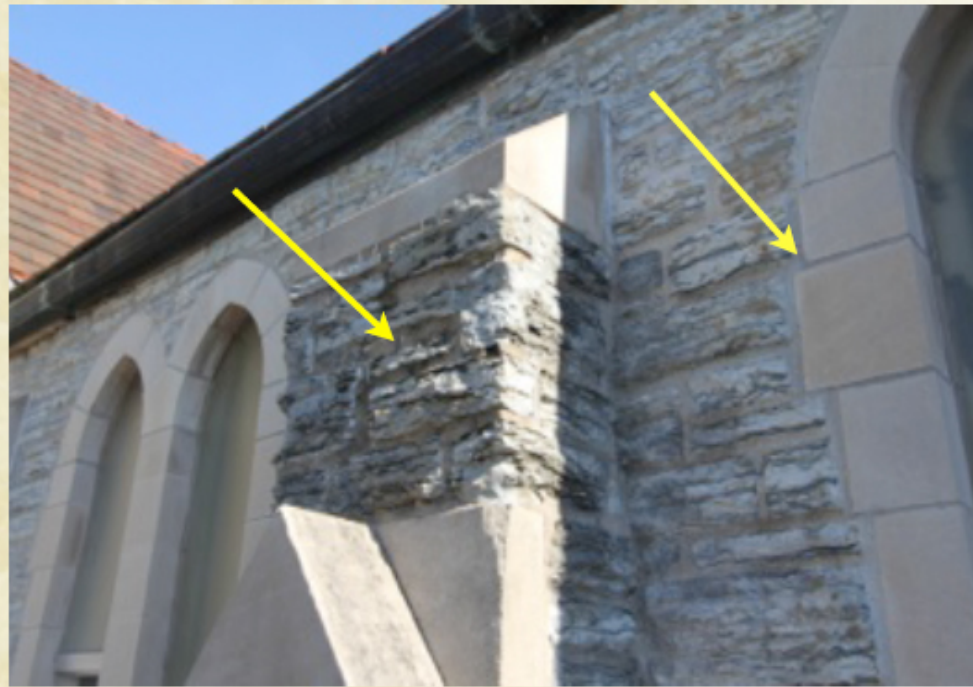
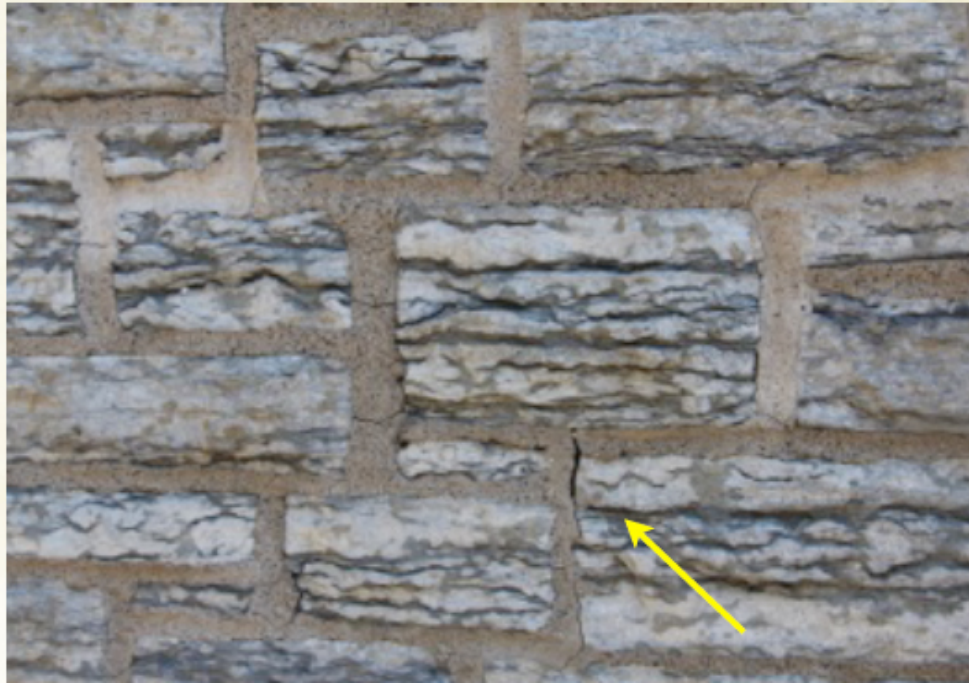
The mortar joints at the pilasters and windows are past their service life. The joints have opened up, creating an avenue for water infiltration. These joints need to be cut out, cleaned and re-pointed with fresh mortar.

This is an example of a deteriorated mortar joint on the building. Similar conditions exist on all elevations.

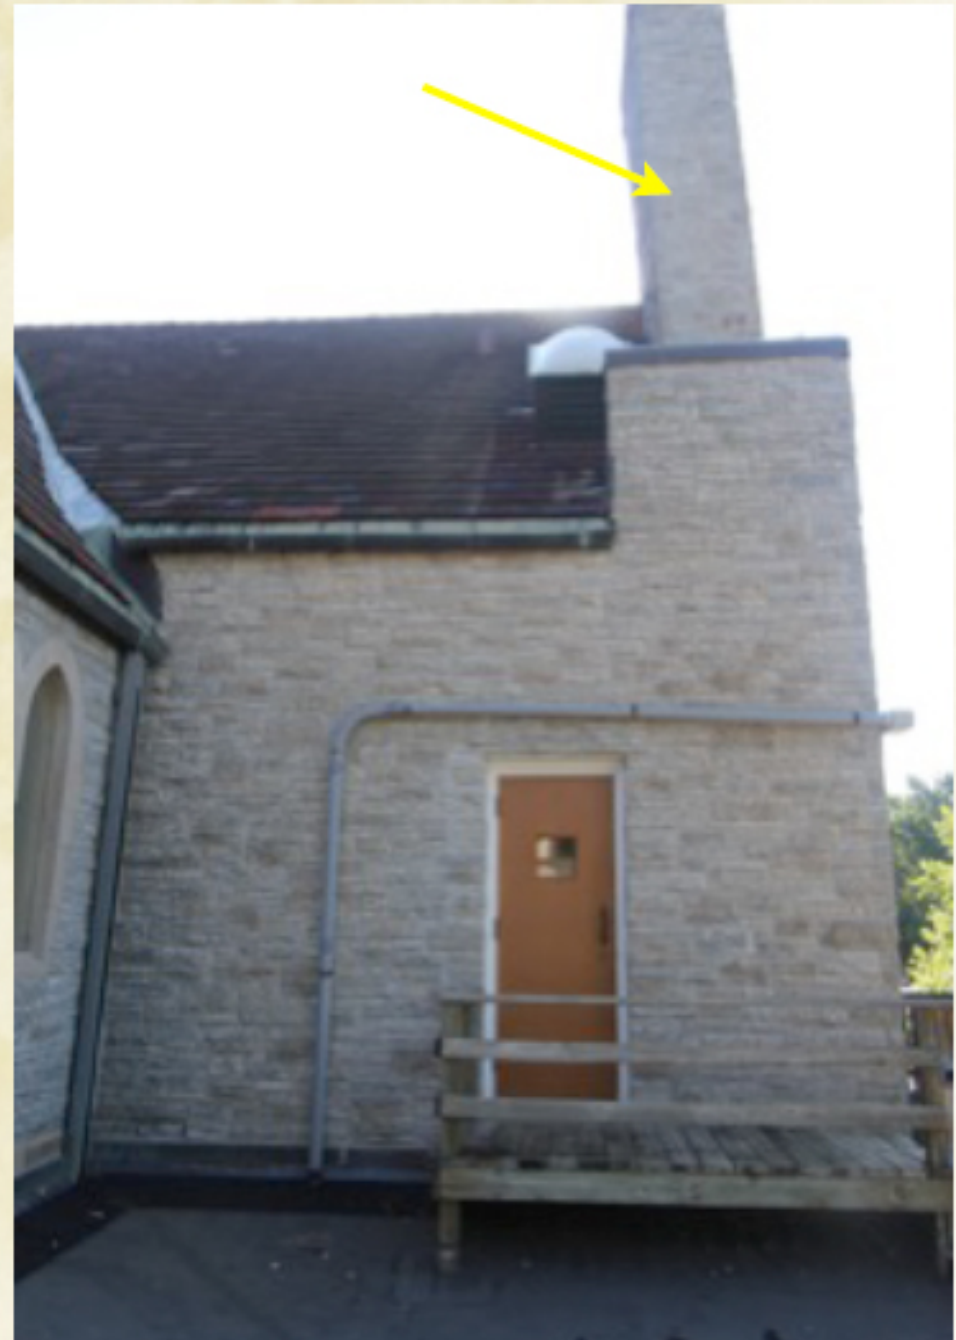
This image shows the extent of the chimney leaning towards the roof. We recommend demolishing the chimney down to roof level and rebuilding it so it is plumb and level.

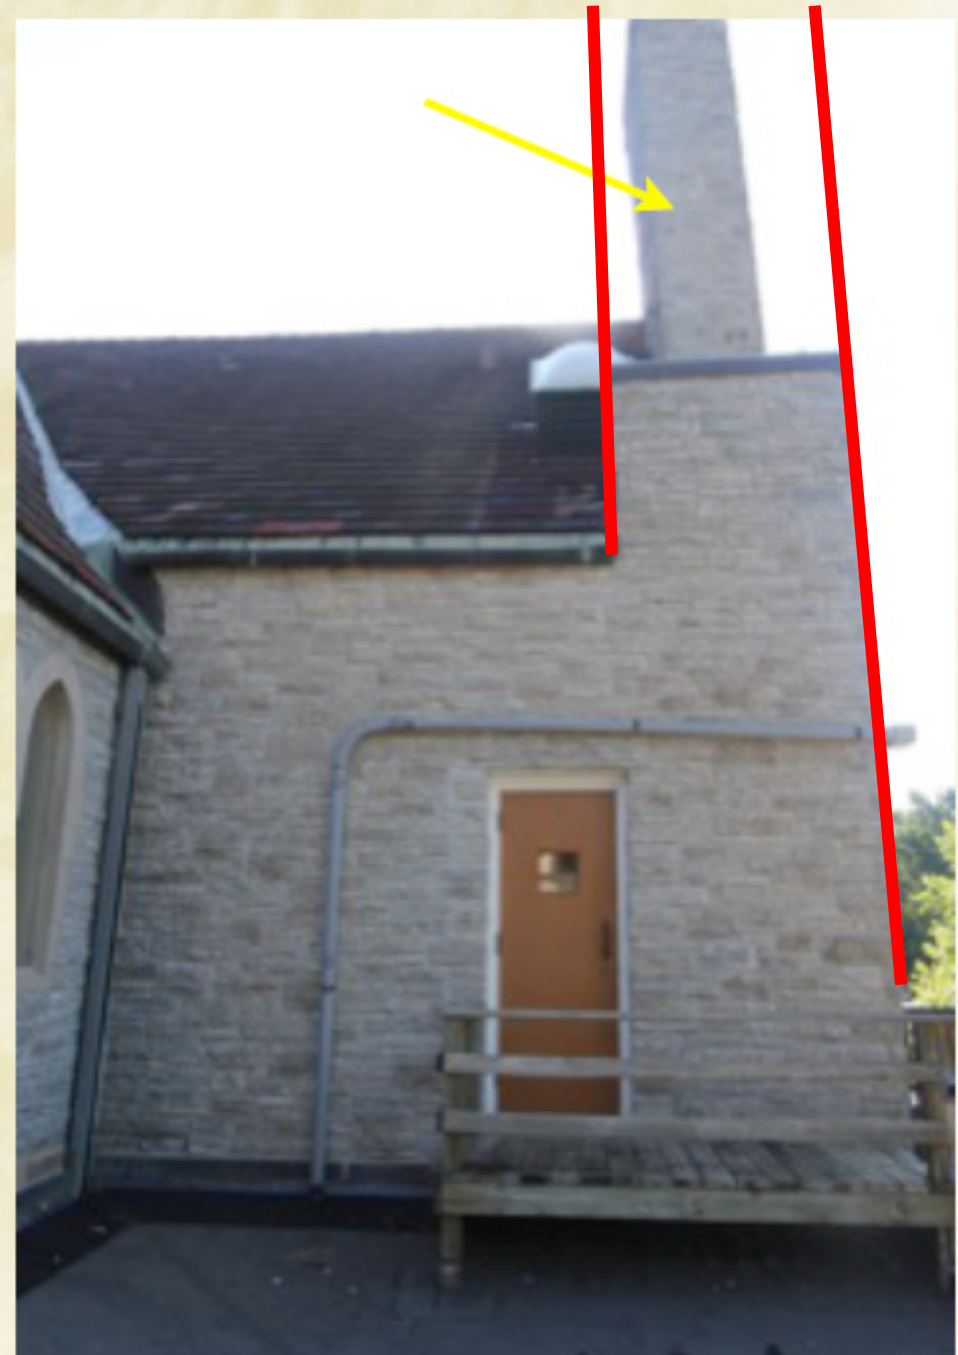
This image shows the extent of the chimney leaning towards the roof. We recommend demolishing the chimney down to roof level and rebuilding it so it is plumb and level.

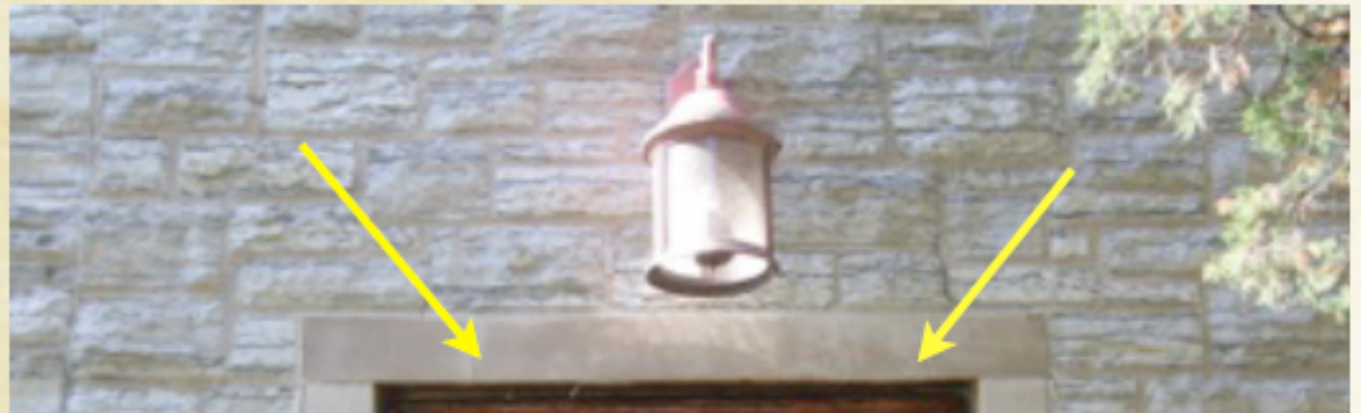
Some of the cast stone headers have cracked. We use epoxy injection to stabilize the cracks.

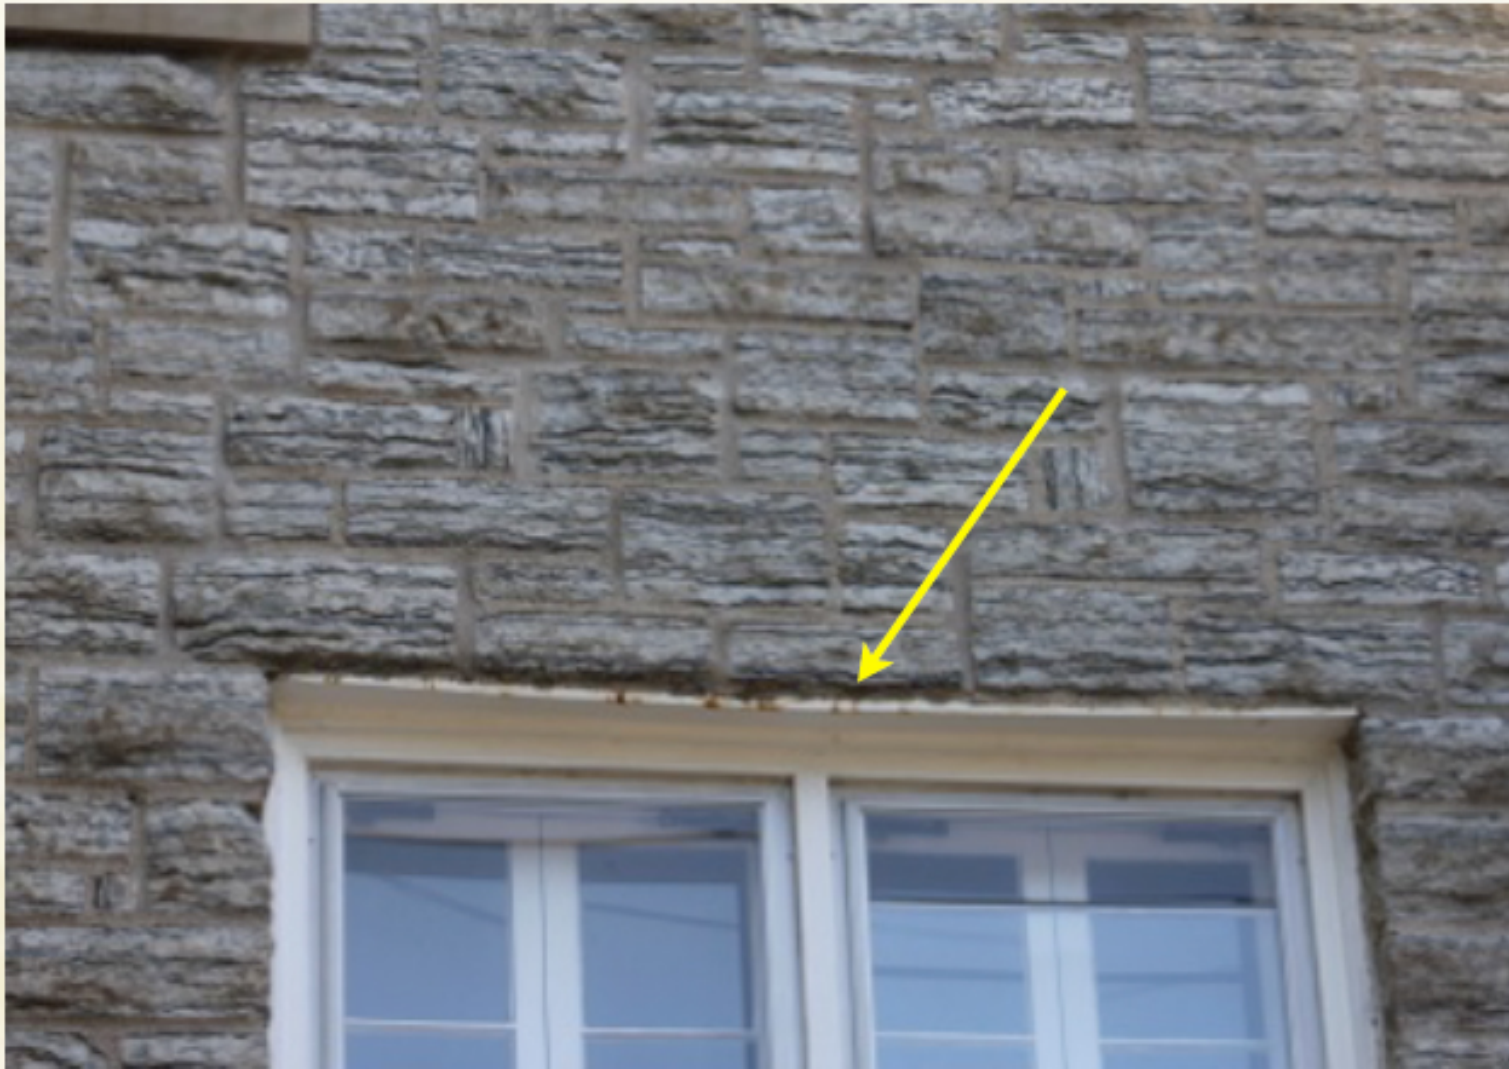
Alternate #1: Installing through-wall flashing where steel window/door headers are present around building. Many of the lintels have oxidized due to water infiltration creating areas of pack rust and warping steel.

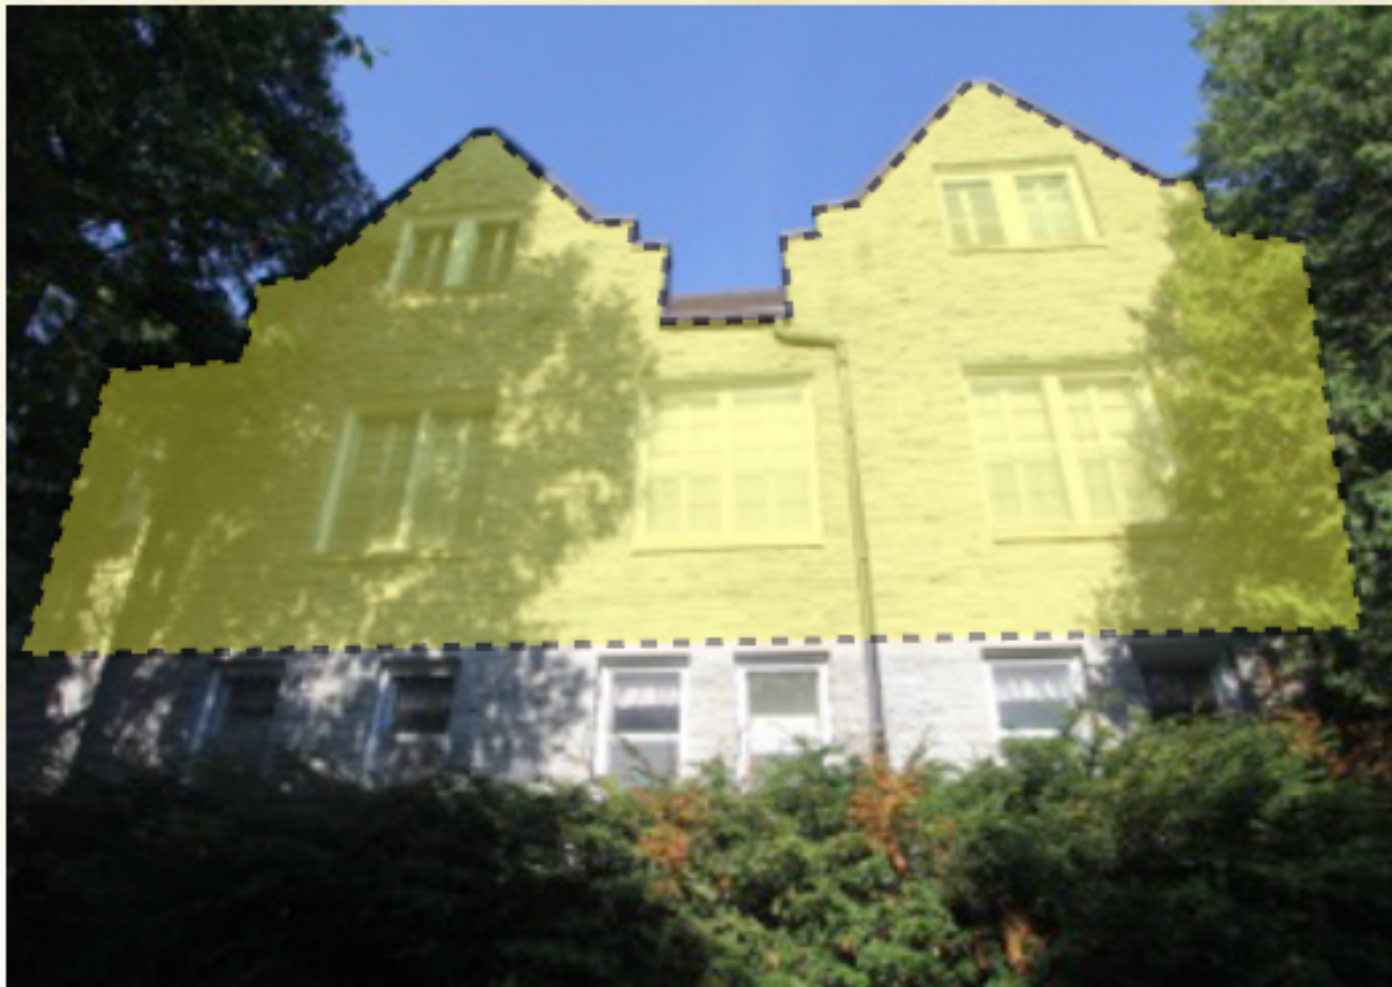
A large section of the exterior stone at the east elevation is bulging and pulling away from the back-up wall.

The existing corrugated steel ties that hold the stone to the sheathing at the back-up wall have failed allowing the stone to move freely away from the wall. This is visible at the vertical sealant joints on both sides of the window jamb.

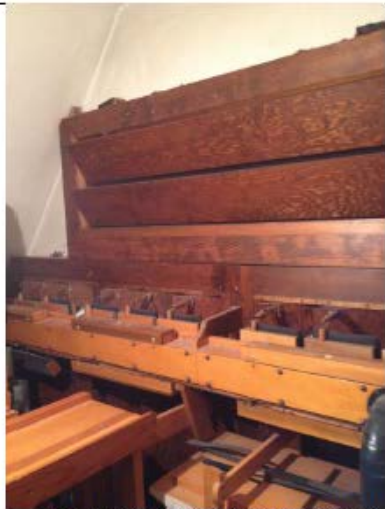
Figure 1: The two horizontal swell shutters. The vertical are below and cannot be seen here. Note that these shutters are WIDE OPEN and do not allow much sound out into the church. The large horizontal box below them is the swell motor mechanism.

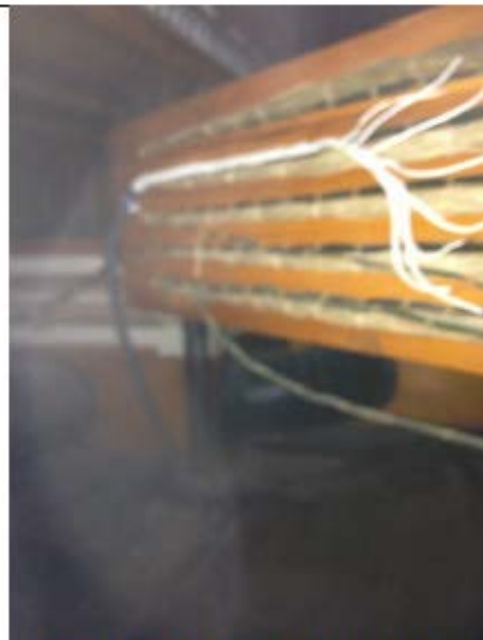
Figure 5: A blurred view of one of the junctions under the wind chest, near the floor.

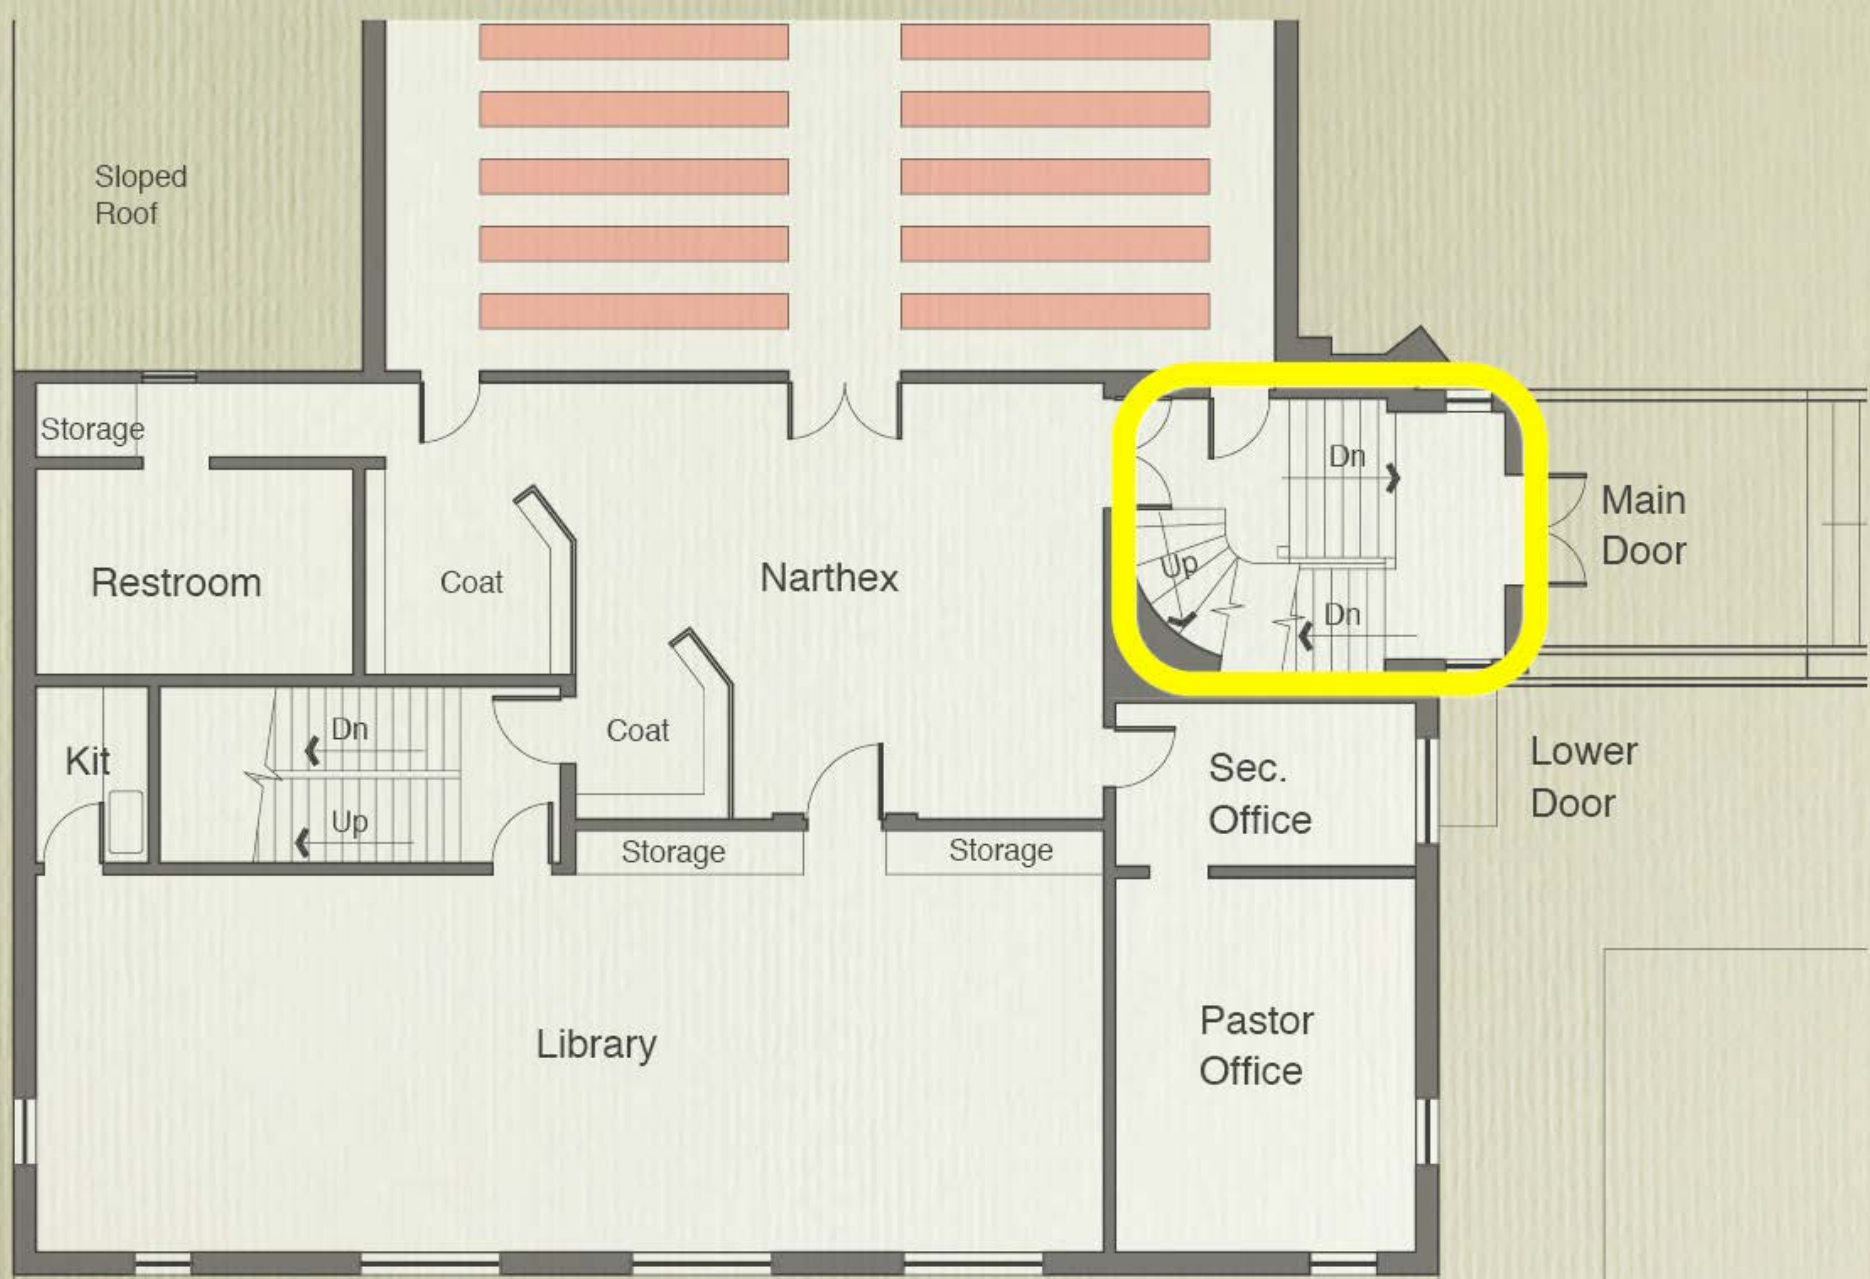
Tight circulation below

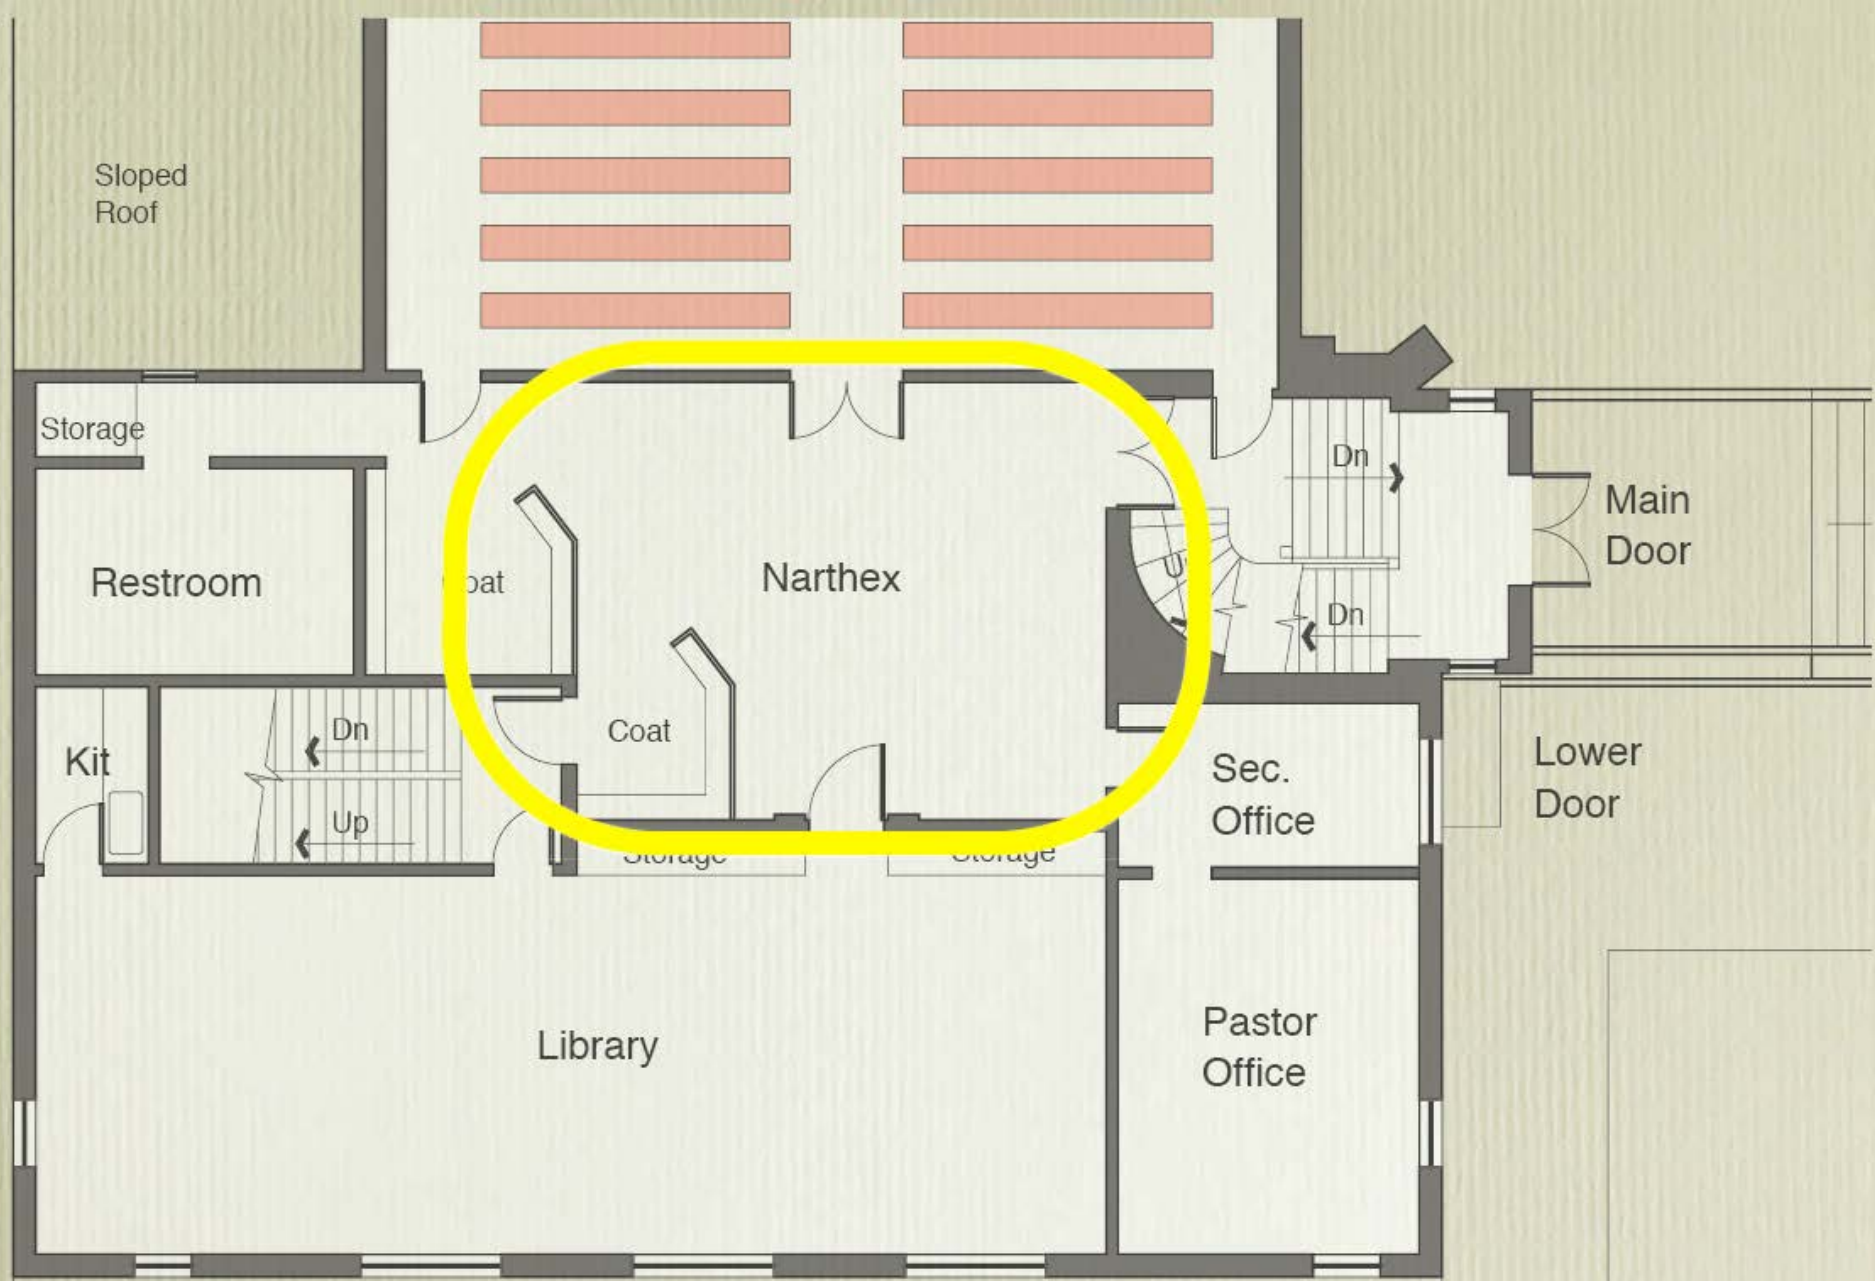
Dark, worn, cluttered, sound and light lock

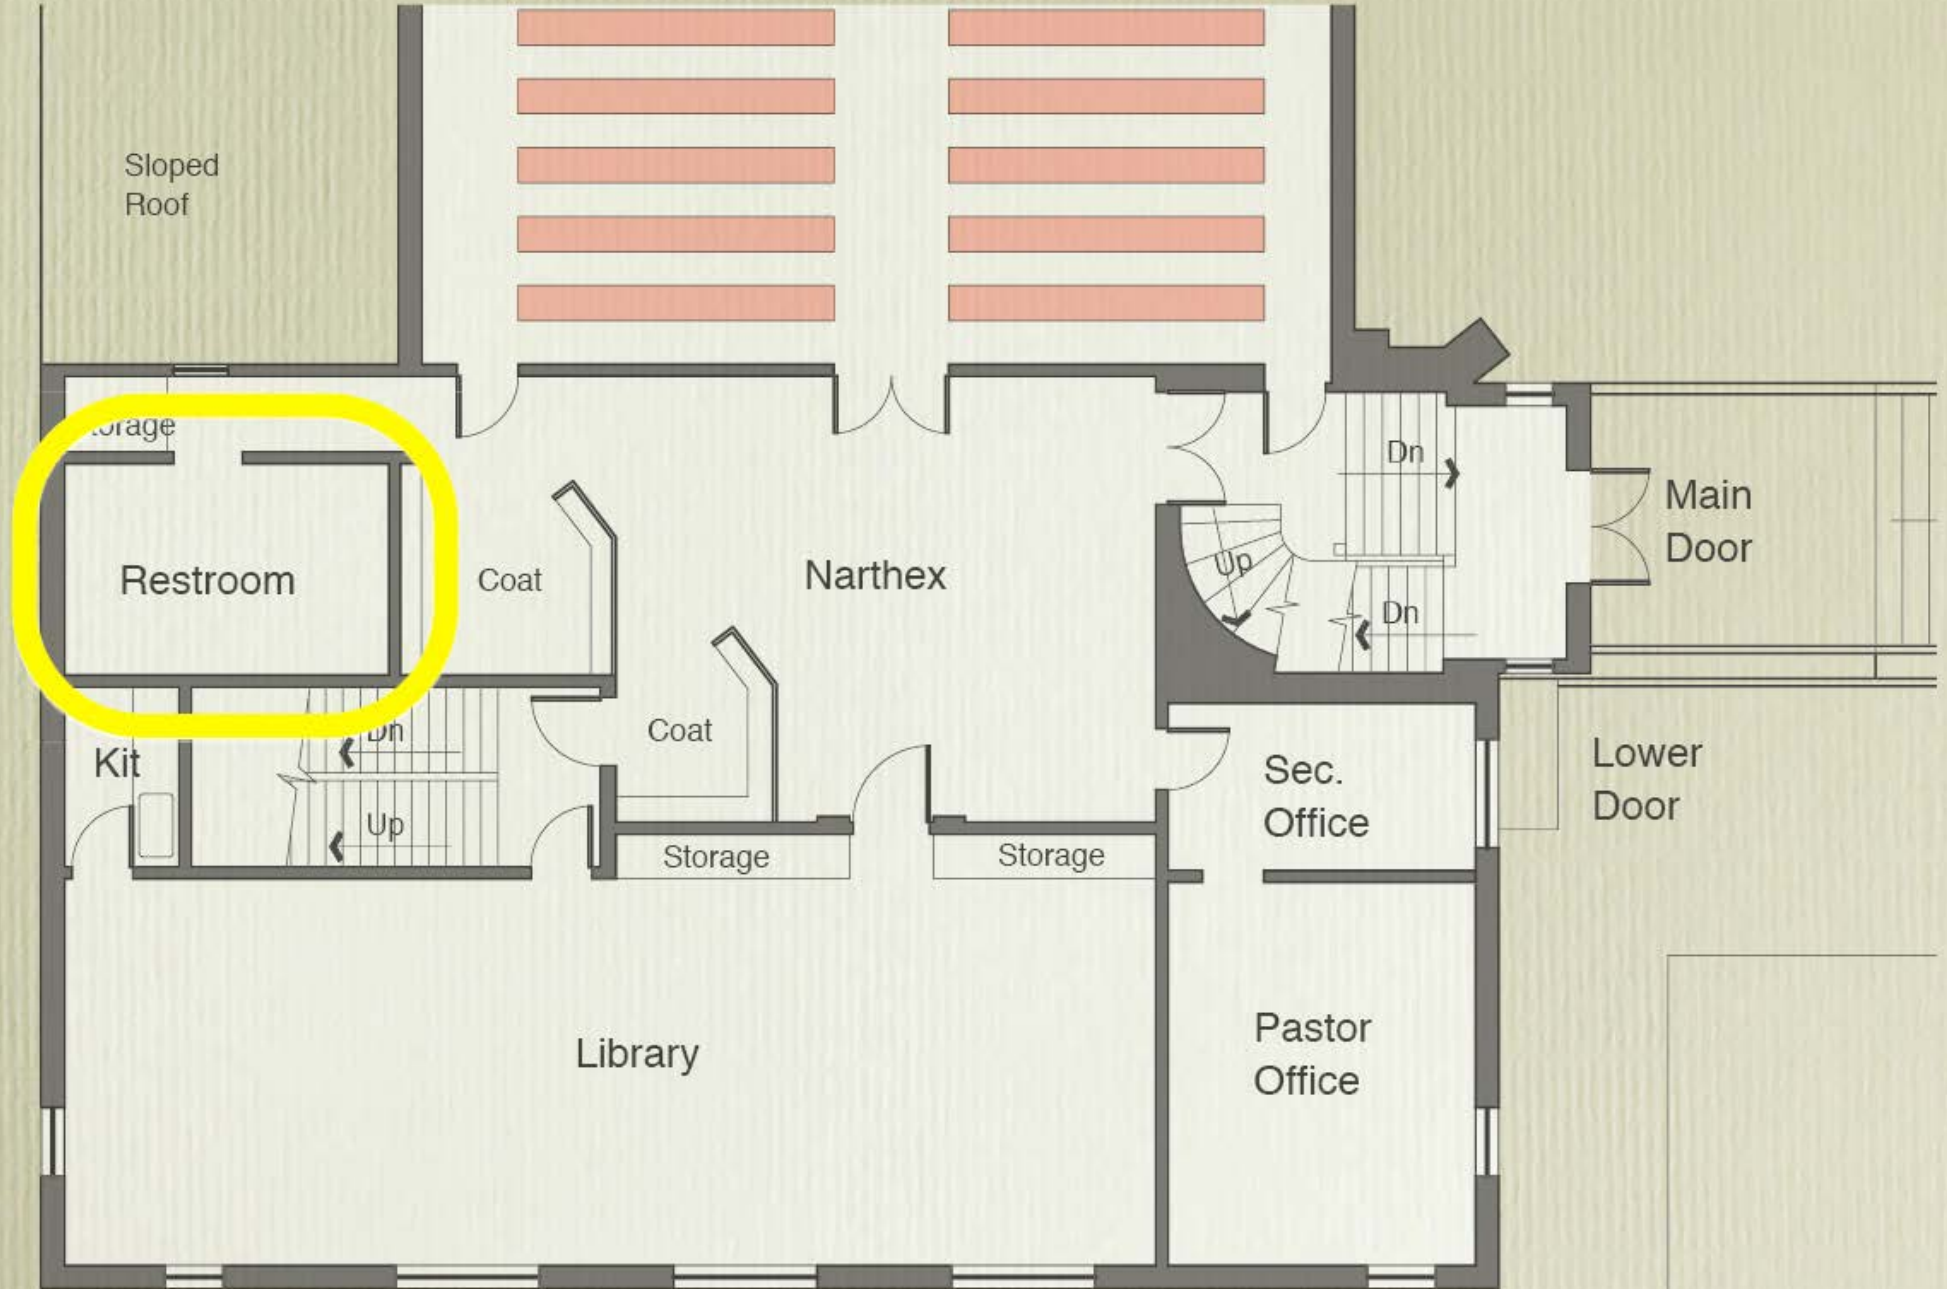
Tight and worn
